St Alban's - Summary of Structural Issues

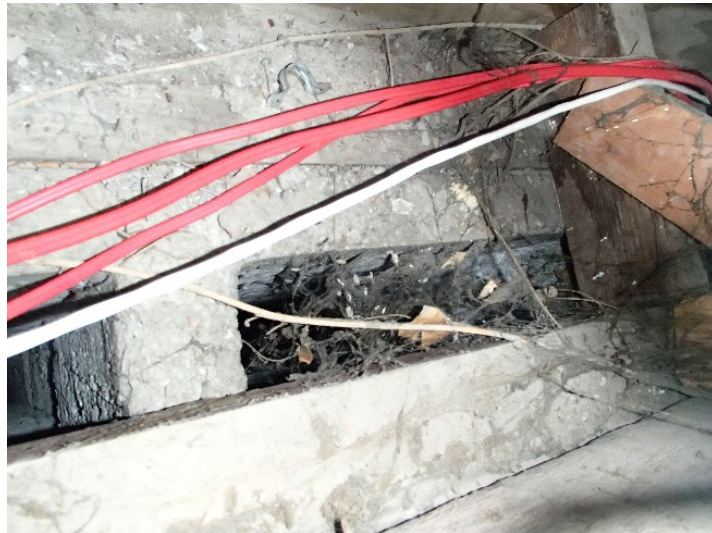
The church building does not have an effective ceiling diaphragm, because it has a high pitch and open ceiling space. Because of this, the side walls have to carry the roof under lateral earthquake loading. The side walls are of camerated concrete construction (void cells between concrete skin walls) with very poor wire reinforcing only.
